G.O. LEOPORANCE
EPRI AP-4342
Project 1195-12
Final Report
December 1985

Chemistry, Scale, and Performance of the Hawaii Geothermal Project-A Plant

Prepared by
Hawaii Electric Light Company, Inc.
Hilo, Hawaii

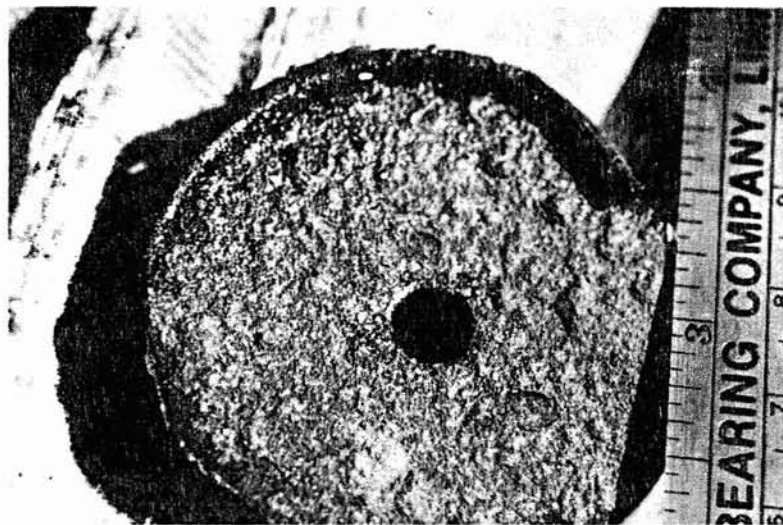
The scale deposition observed at the first location is presented in Figure 3-2. The thickness of the scale layer observed was approximately 0.04 inches (1 mm). The scale is easily friable and has a somewhat foliated texture. The bottom of

Figure 3-2. Top Sample of Main Steam Line Before Venturi. Scale consists predominantly of pyrite. Scale thickness is approximately 1mm.

1. Install additional brine/condensate dropout points downstream of the primary separator.
2. Install automatic nitrogen blanketing capability for use during turbine outages.
3. Install automatic anti-oxidant injection capability for use during turbine outages.

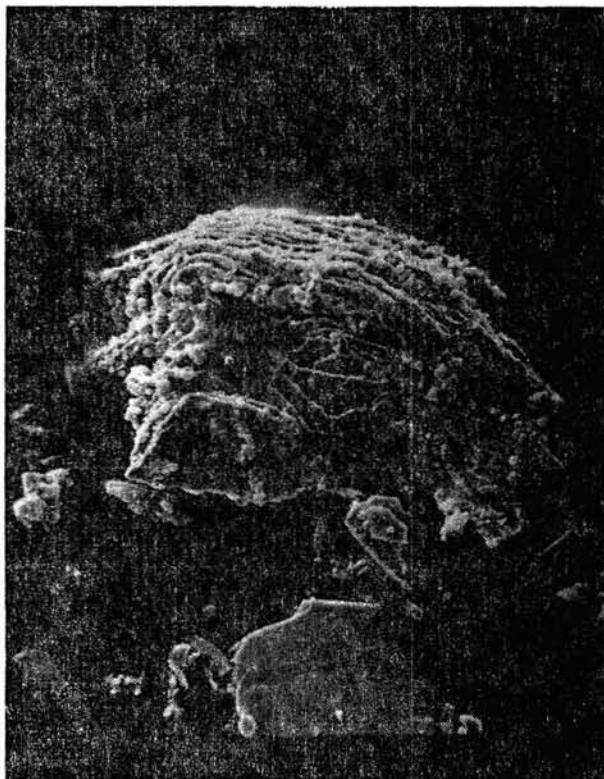
Scanning electron microscopy of the scale from this location showed the texture to be layered (Figure 3-8) but, even at high resolution, crystalline structures were not resolvable. The amounts of scale present at this location were again inadequate to allow an x-ray diffraction analysis of the mineralogy.

Figure 3-8. Micromorphology of scale deposits - Main Steam Line Before PV601 (620 x*Magnification)

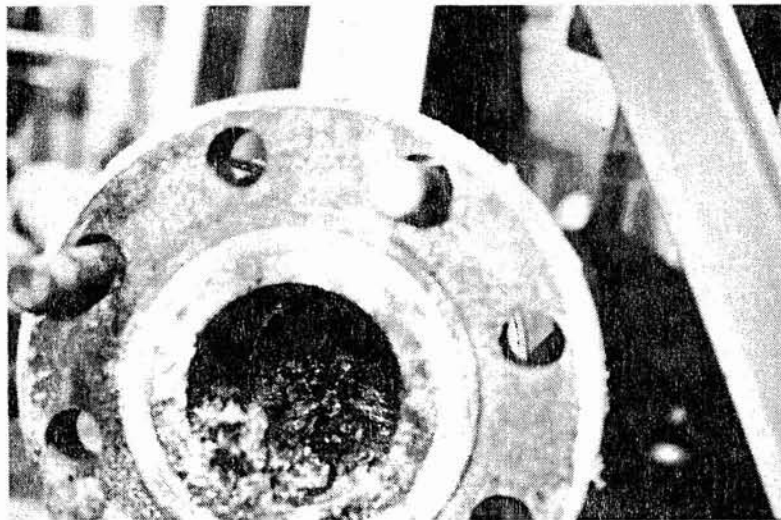
Figure 3-10. Moisture Separator - Bottom Drain. Mixed iron oxide, iron sulfide scale.

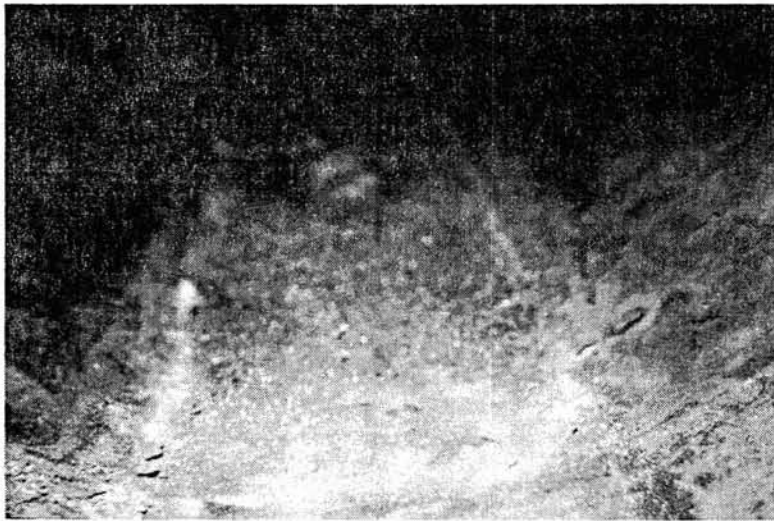
Figure 3-11. Main Steam Line Bottom - Inlet to Control Valve

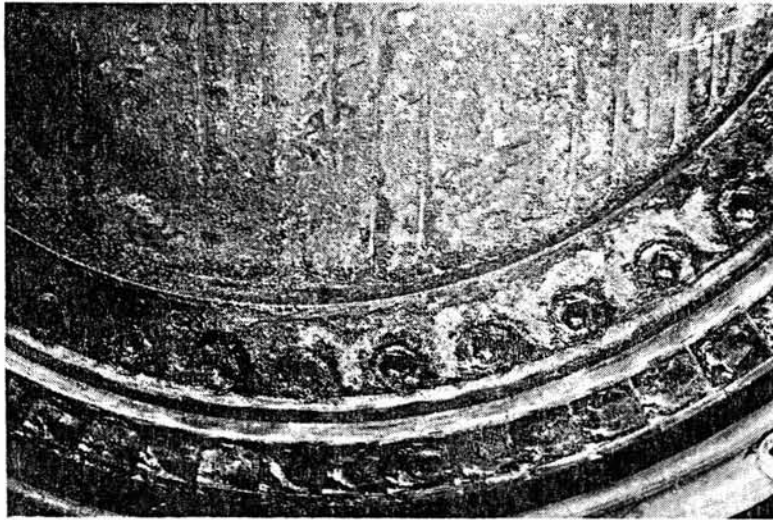
Figure 3-12. Nozzle Block Overview. Scale consists of mixed iron sulfide accompanied by silica. Scale thickness ranged from 0.025cm to over 0.25cm.

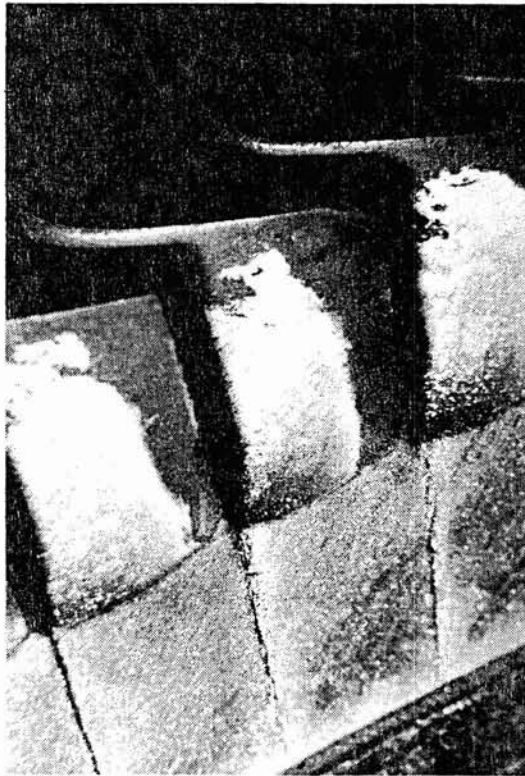
Figure 3-15. Turbine Wheel #1 Outlet
Blade Side. Scale consists of the iron
sulfides, pyrite and pyrrhotite.
Maximum scale thickness is 0.04cm.

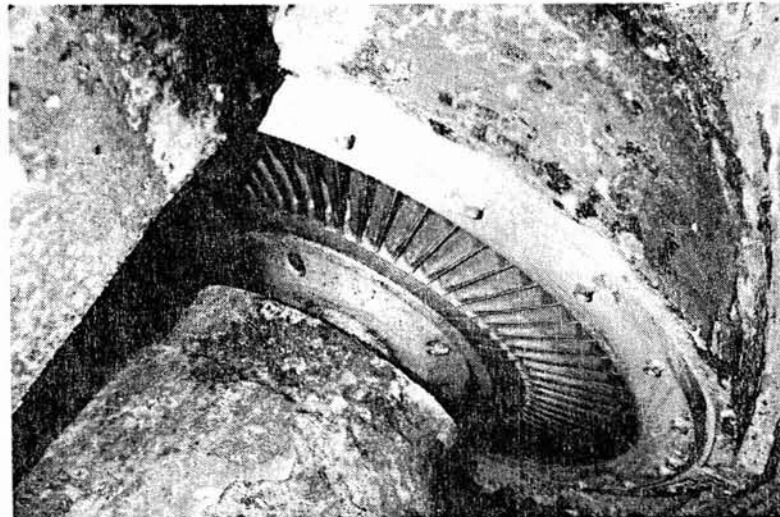
Figure 3-21. Turbine Exhaust Outlet. Scale consists of pyrite, pyrrhotite and mixed iron oxides.

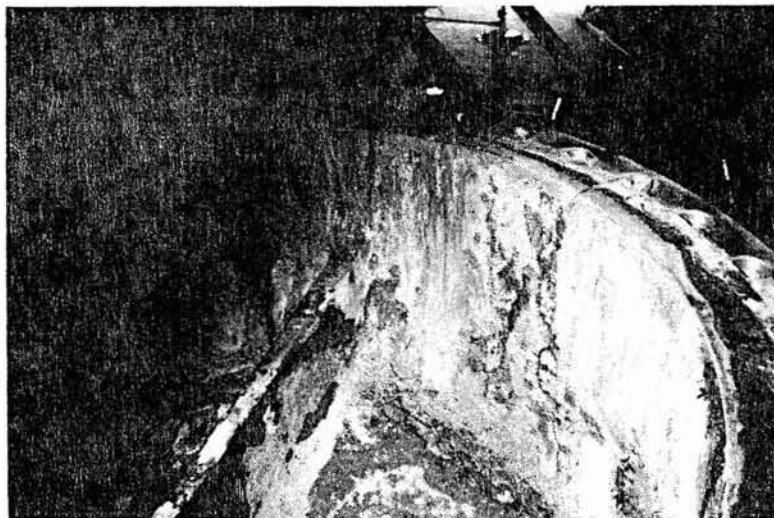
Figures 3-21 and 3-22 show the condition of the turbine exhaust when the 36 inch (91.4 cm) diameter outlet pipe was removed. The scale was much lighter than that found upstream and consisted predominantly of iron sulfide with pyrite granules. The inside of the 36 inch (91.4 cm) diameter outlet pipe was coated with only a light, soft material that could be wiped off.

Figure 3-22. Turbine Exhaust Top End of Outlet

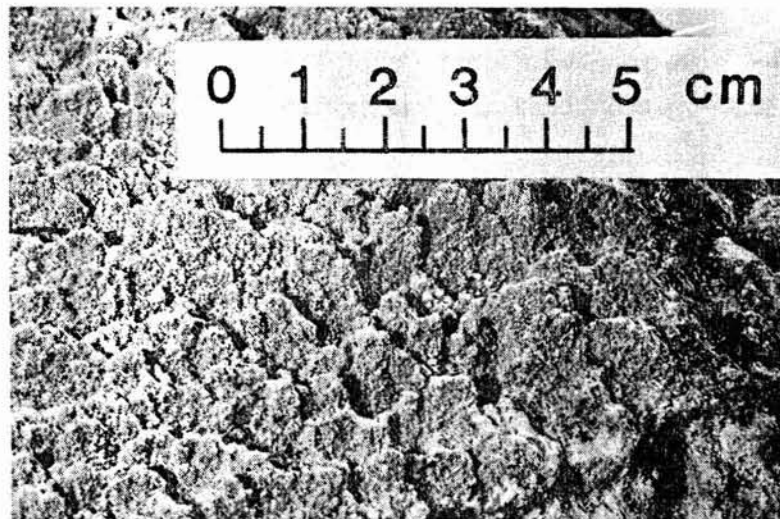
The second sampling point in the process stream evaluated was the primary brine separator. This vessel is approximately 4 feet-7 inches (1.4 m) in diameter and 17 feet-10 inches (5.4 m) high. Access to the separator was through a manhole located approximately 3 ft. (0.9 m) above the bottom of the vessel. Removal of the manhole cover revealed a thick accumulation of silica in the "dead-space" between the cover and the walls of the vessel (Figure 4-5). This material had an extremely rough surface (Figures 4-6 and 4-7) and consisted of poorly cemented particulates that were easily friable. The interior walls of the separator were coated with a similar appearing scale ranging in thickness from a few millimeters in the upper section of the separator to approximately 2 cm near the bottom. This material was more solidly cemented and more firmly attached to the vessel walls than was the accumulated material at the manhole. It was also apparent, however, that slabs of the former had broken free of the vessel walls and had formed an accumulation near the bottom of the separator that had subsequently been cemented into a nearly solid mass (Figure 4-8).

Figure 4-7. Scale Deposits - Flash Separator (Close-up)

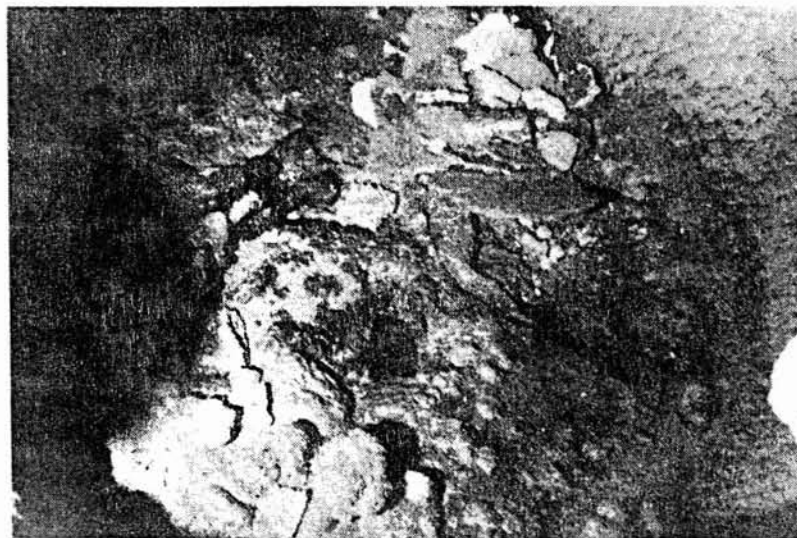
Figure 4-8. Flash Separator Floor

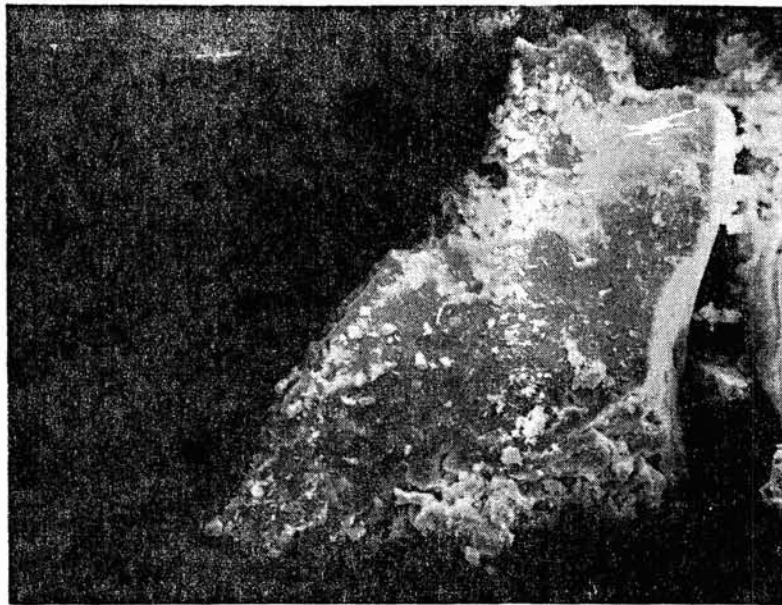
X-ray analysis of the scale from the separator indicated that this material was composed primarily of silica; however, hand lens examination, as well as the coloration of this material, indicated that small amounts (<5%) of iron sulfides are present as well. Scanning electron microscopy showed the scale to be a mixture of extremely fine particulates mixed with larger fragments of cemented particles (Figures 4-9 and 4-10).

Figure 4-9. Micromorphology of Silica Scale - Flash Separator (420 x*Magnification)

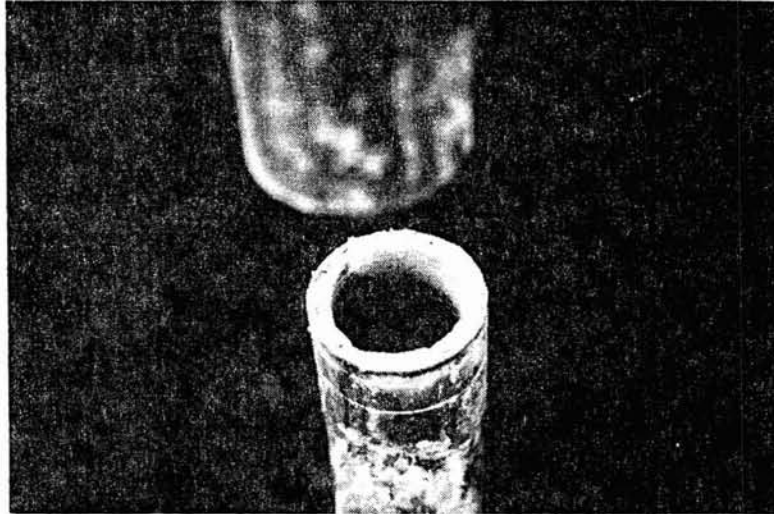
Figures 4-13 and 4-14 show the silica deposition in the brine piping approximately 10 feet (3.05 m) from the separator exit point. The silica layer is approximately 0.234 inch (0.594 cm) and appears to be of two distinct types. The outer layer (adjacent to the pipe wall) is chalky and moderately friable whereas the inner layer is more vitreous and harder. Both layers show a wave-like surface texture with the sharp edge of the waves facing into the direction of flow.

Figure 4-13. Scale Deposits in 3" Brine Piping 10 Feet From Separator

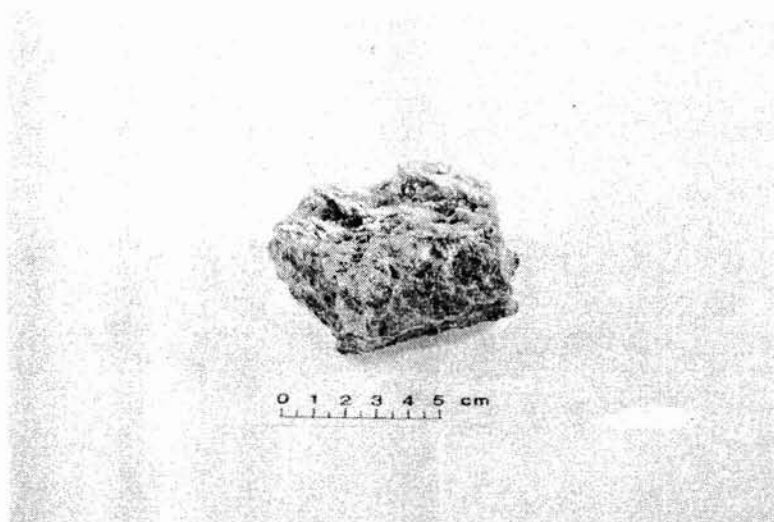
Figure 4-22. Silica Deposits on Muffler Box Discharge Line. Scale is silica, 2-3 cm thick. Note denser texture.

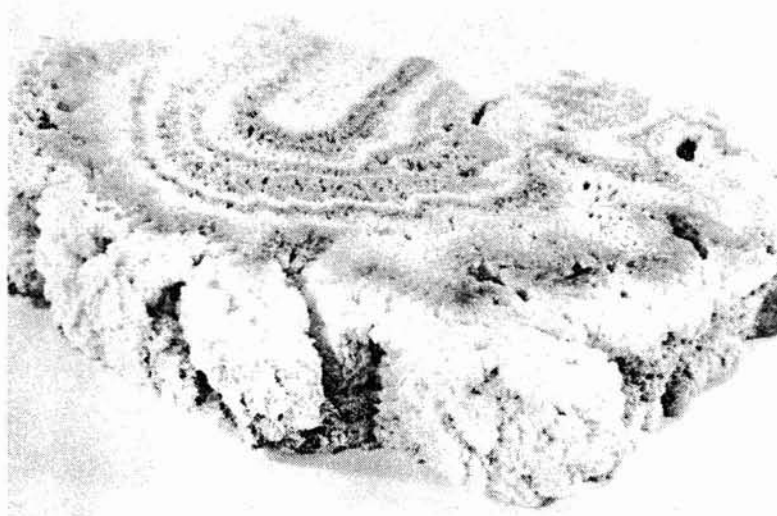
surface and subsequently grew outward from the thin layer originally formed. It is also of note that the outer friable layer was underlain by a thinner layer of massive vitreous silica; these features are clearly evident on Figures 4-23 and 4-24 where the more vitreous layer appears in the outer dark gray layer. The inner gray layers correspond to slightly higher concentrations of sulfides in the silica matrix.

Figure 4-24. Silica Deposits - Brine Retention Pond (Close-up)

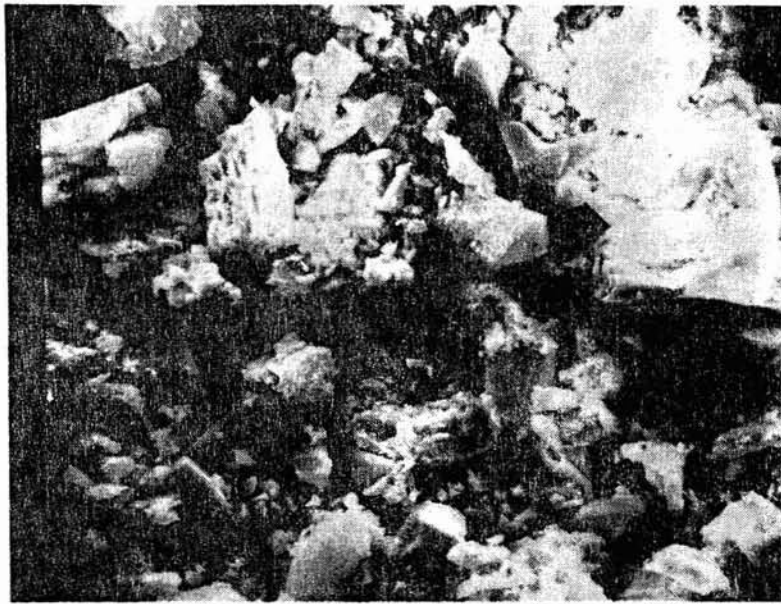
The micromorphology of these two types of silica is shown in Figures 4-25 to 4-28. The dendritic scale in Figures 4-25 and 4-26 is clearly an open structure with numerous solution cavities whereas the vitreous material is more solid with virtually no porosity. It is hypothesized that the more open scale structure precipitates initially and is subsequently cemented into a solid mass as brine circulates through the solution cavities present in the original structure.

Figure 4-25. Micromorphology of Silica Scale - Brine Retention Pond (550x*Magnification)

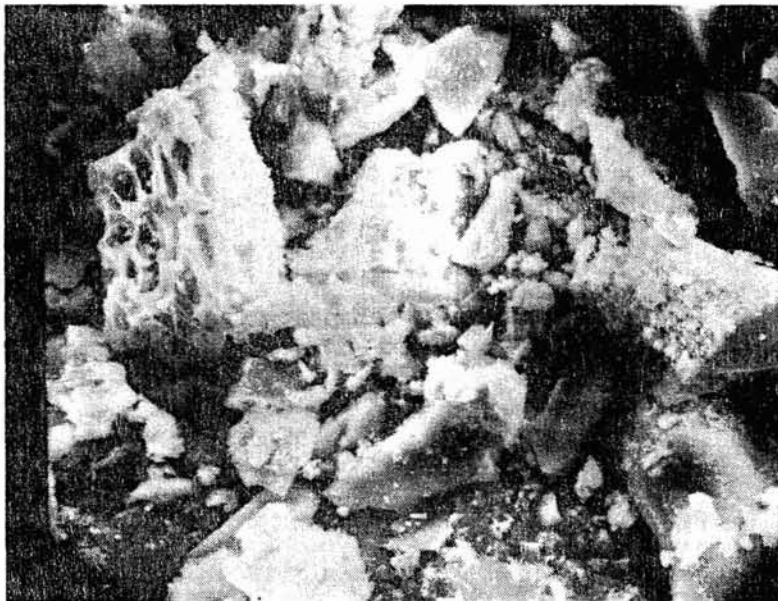
Figure 4-26. Micromorphology of Silica Scale - Brine Retention Pond (1100 x*Magnification)

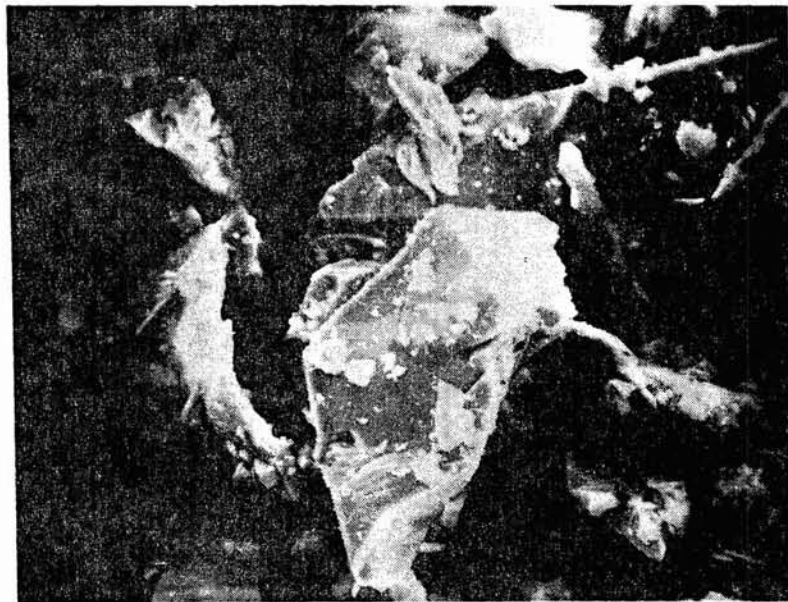
Figure 4-27. Micromorphology of Silica Scale - Brine Retention Pond (600 x*Magnification)

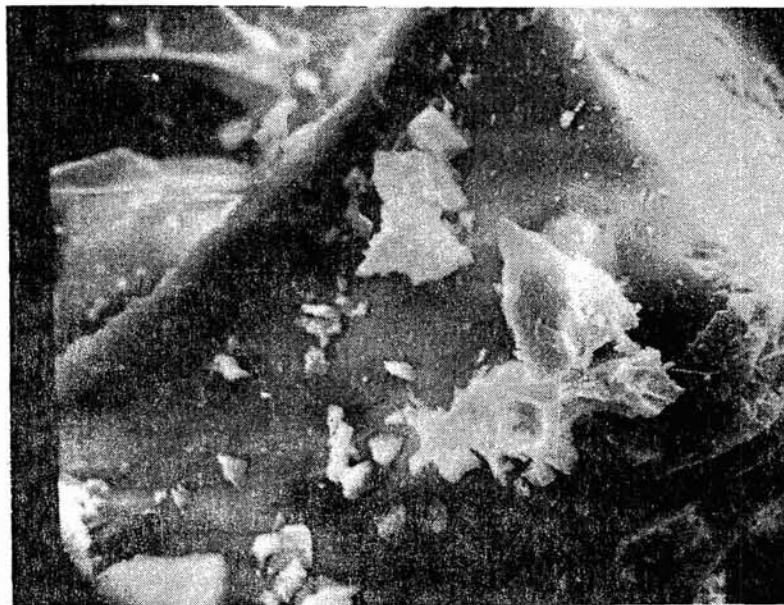
Figure 4-28. Micromorphology of Silica Scale. Brine Retention Pond (2400 x*Magnification)

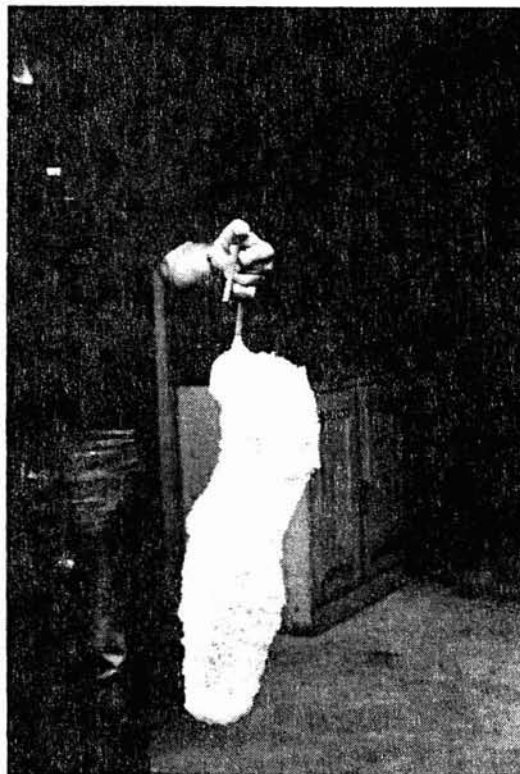
Figure 4-32. Progress of Silica
Deposition in Retention Pond, Sample 4.
Scale thickness ranges to 10-15 cm.
